*Lantern Building, Pittsburgh, PA
Virage Rainscreen System*

Case Study *The Lantern Building, Pittsburgh, PA*
Virage Rainscreen System, Vertical Application

Project Profile

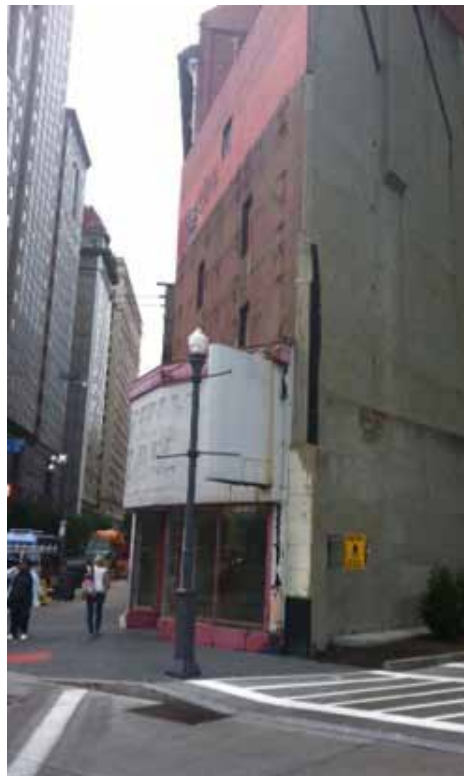
Before

The former Liberty Travel building located at 600 Liberty Avenue in Pittsburgh was an underutilized masonry building which had fallen into disrepair and was being used primarily as advertising space with two billboards affixed to the façade and roof. PNC Financial Services purchased the building and retained Edge Studios to transform the eyesore into a landmark building in the vibrant downtown district. The entire façade was refreshed with translucent glass and rich naturally oxidized zinc panels. Bunting was subcontracted by Turner Construction engineer, manufacture and install the Virage Rainscreen System using zinc panels in a vertical orientation.

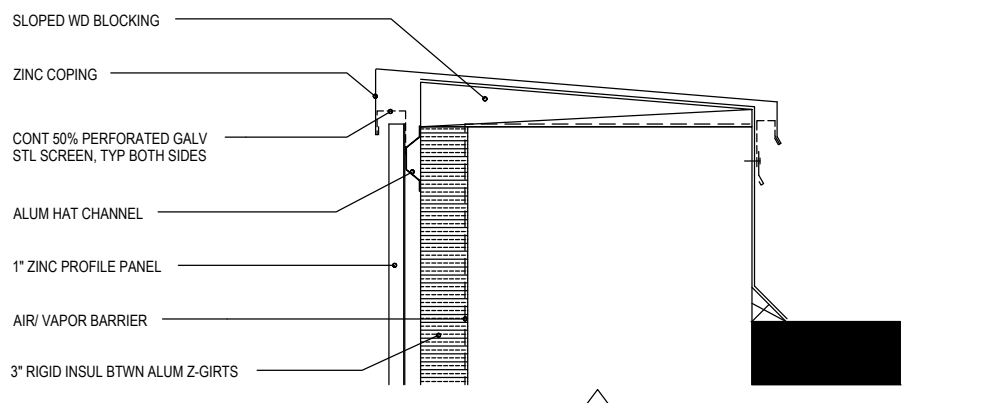
10 PARAPET DETAIL @ EXG FIRST FLOOR ROOF
1 1/2" = 1'-0"

Basis of Design

The bridging documents showed a "Z" girt framing on the west elevation. Since the building was more than 100 years old and out of square, this design would not work.

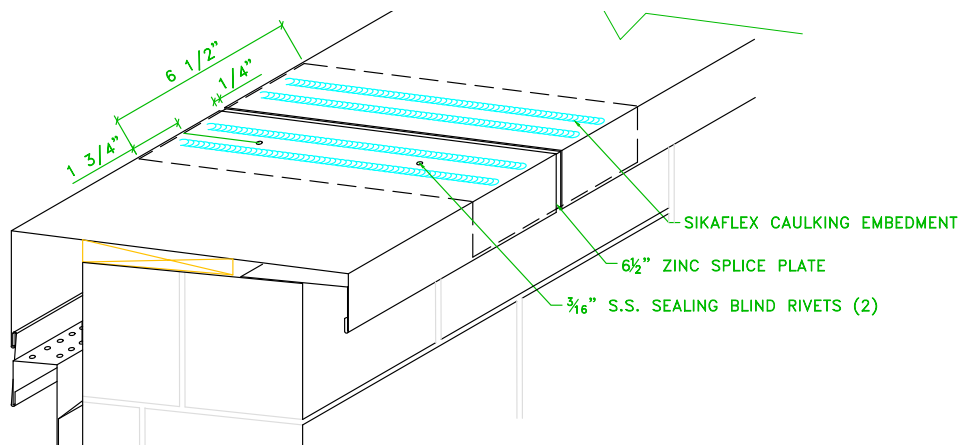
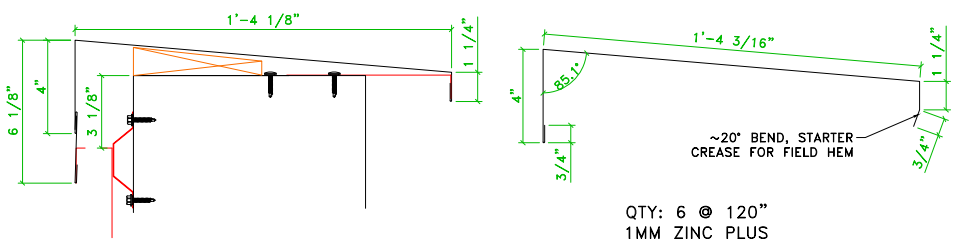
1 ZINC+ PARAPET CAP, WEST
NTS

Approved Construction Detail

Bunting designed and engineered a self-leveling girt assembly to account for the uneven mounting conditions.

QTY: 6 @ 120"
1MM ZINC PLUS
SHEAR TO 23" X 120"
PLUS FINISH ON UNDERSIDE
SLIP HEM @ 4" SIDE

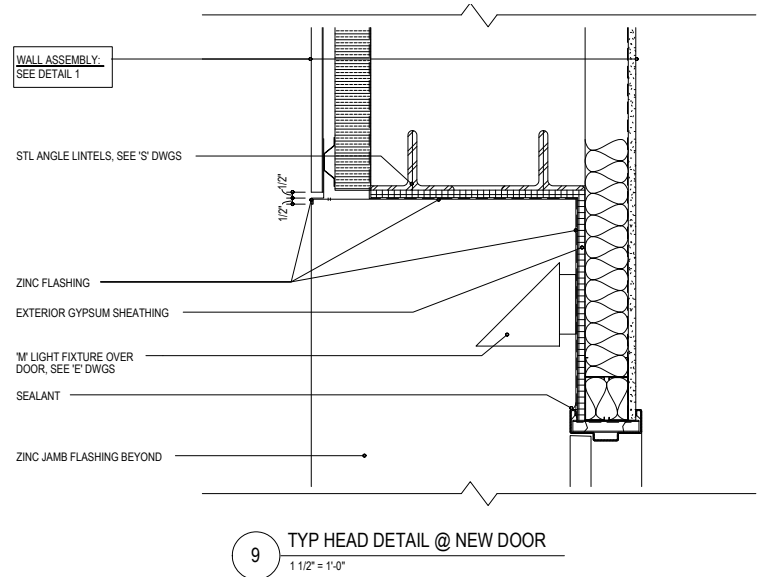
Basis of Design

Bridging documents showed flashing details at the headers for the west elevation doors, but no details for the jambs.

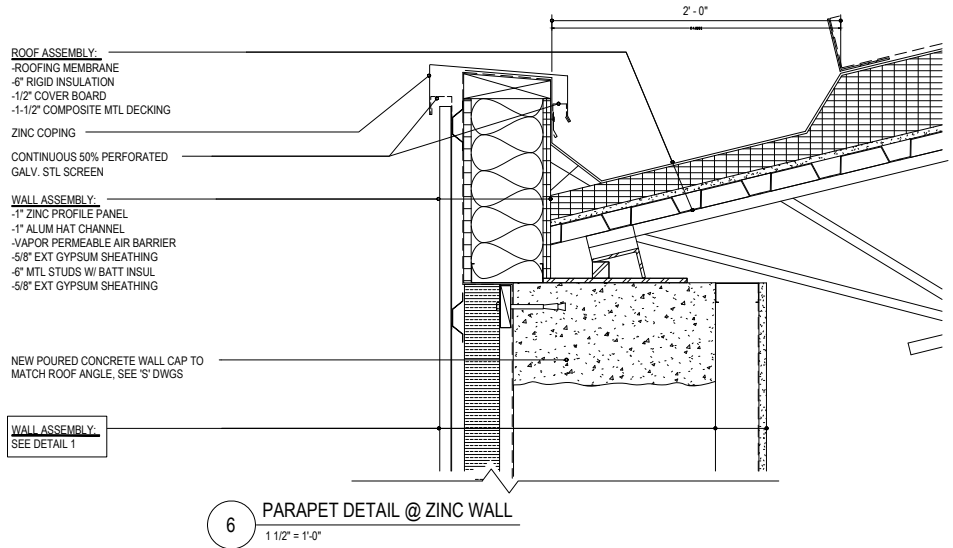
Basis of Design

Unforeseen changes occurred during construction requiring the general contractor to rebuild the top sixteen feet of exterior wall out of CMU block which changed the slope of the building.

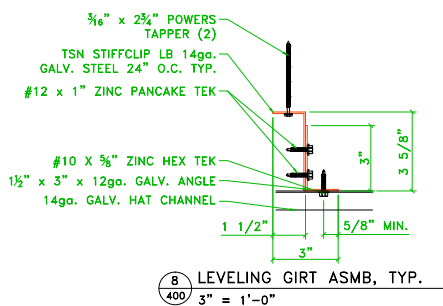
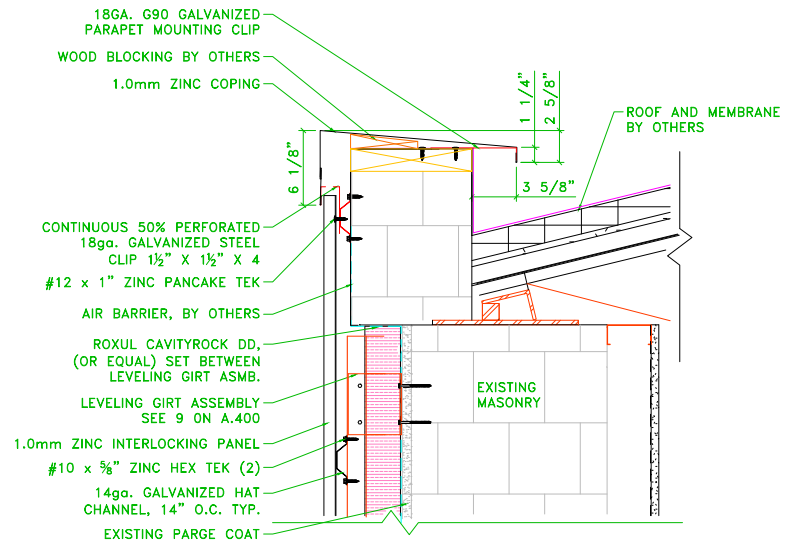
Approved Construction Detail

Bunting designed and engineered an alternate parapet cap.

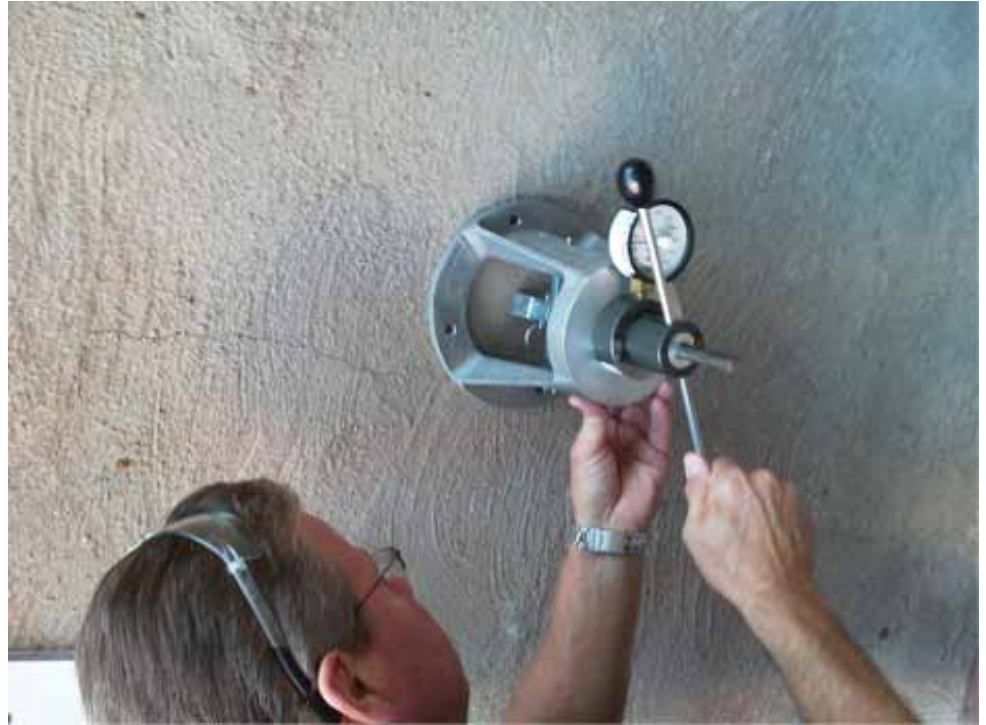
Approved Construction Detail

In order to ensure the integrity of the façade, Bunting performed pull-testing on site to verify the actual pull-out capacity of the screw fasteners.
